Mansagar Lake: Past, Present & Future

ABSTRACT

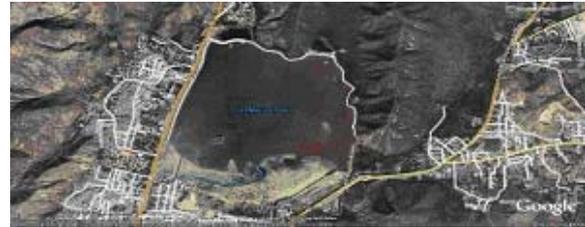
Figure 1a. Satellite photograph of Mansagar lake.

The Mansagar lake is a large manmade lake on the northern fringe of Jaipur city. Maharaja Mansingh I (1590-1619) impounded Darbhavati river and Nagtalai nala on the north side of the Khilangarh fortress by constructing a dam in 1610 that created this lake (Fig.1a). The lake is approximately 130ha in its spread with a maximum depth (>7m) at the dam's outflow point. It has a catchment of 23.5km², about 40% of which falls inside the dense urban area is presently the major source of water (about 90%) in the lake in the form of storm water runoff during rainy season while sewage in the dry weather. The remaining 60% watershed in the form of denuded and forested hills virtually contributes very little on account of impediments such as human settlements and hotels in the foot hills on western side and construction of roads on three sides of the lake (Fig.1b). The maximum level of the lake is at 99.0m contour at which volume of water is 3136569.75MCM.

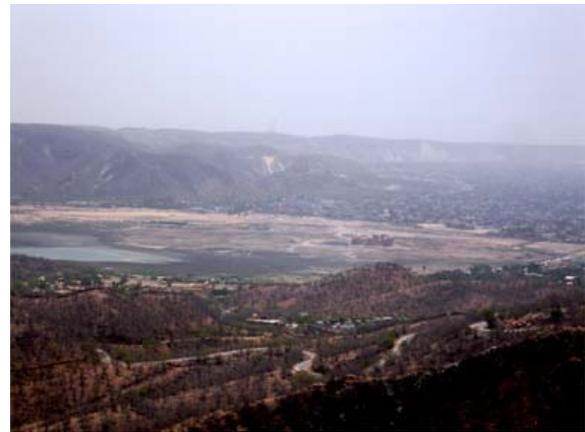
Figure 1b. Mansagar lake during summer (2007).

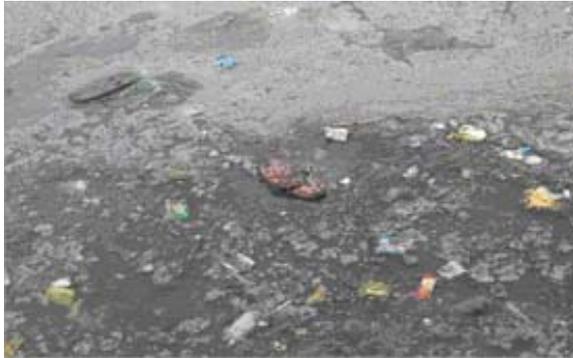
rains possibly increased microbial activity in the loose sediment (due to desilting) consuming dissolved oxygen of water. A sudden change in water qualities was unfavorable to the aquatic fauna, especially fish that led to their mass mortality during the rainy season of 2007 (Fig. 2).

Fig. 2. Fish mortality following lake desilting in the rainy season.

Water samples were also calloused from the pits formed during lake desilting by Jalmahal Resort Pvt. Ltd. in 2006 summer and recorded very high sulphate content (1036ppm). The lake water also had high sulphate content following rains, in comparison to the year 2005 (Table 3). Sediment is rich in organic matter including of heavy metals (Table 4). It is likely that desilting exposed metallic sulphides

(insoluble in water) in the sediment to atmospheric air that oxidized them in to water soluble sulphate. The sediment spread over for raising platform of land adjoining southern bank of the lake during desilting in the year 2006 might have also contributed sulphates (possibly of heavy metals) through leaching in the rainy season (Table 3). The onset of

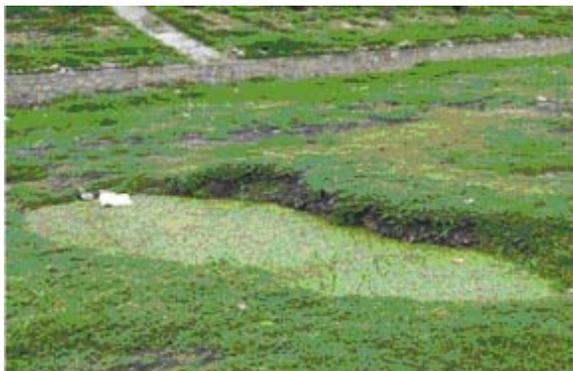
The small pools formed in the lake bed following receding of water level during summer had prolific growth of *Spirodela* (Fig. 3). The rich algal bloom formed in the ensuing months (September-October) however, killed *Spirodela* possibly due to allelopathic effects (Fig 4).

Fig. 3. *Spirodela* in a ditch in the lake bed.

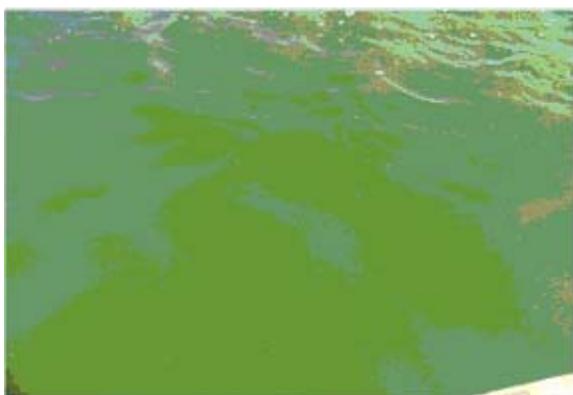
Fig. 4. Algal bloom formed during rainy season.

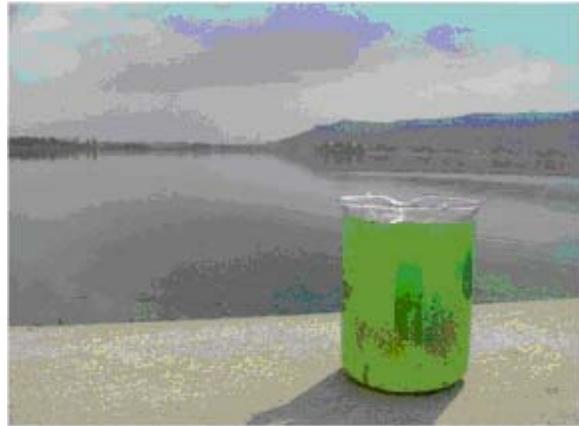
Algal blooms are common during warmer period of the year (April – October) forming thick scum on the water surface, especially along the bank in September spread further in October covering a larger part of the lake. The water samples collected from such areas are dark green in color (Fig. 5).

Fig. 5. Dark green lake water during the rainy season.

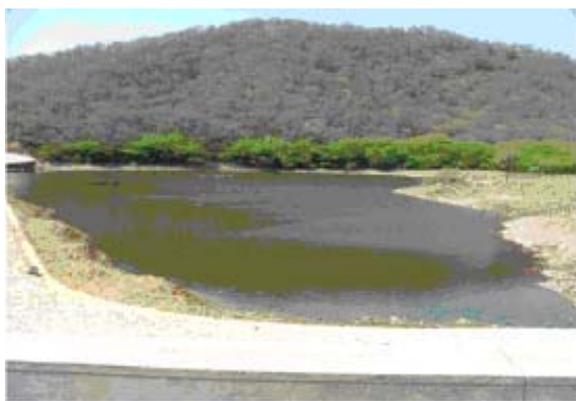
The road construction along the lake has formed a new water body (about 5ha in size) hereafter termed as check dam for storing hill run off during rainy season to wild life which includes Hanuman langur (*Semnopithecus entellus*), Black-naped Hare (*Lepus nigricollos*), Indian Porcupines (*Hystrix indica*), Blue bull (*Boselaphus tragocamelus*), Sambhar (*Cervus unicolor*), Common Mongoose (*Herpestes edwardsii*), Jackals (*Canis aureus*), Striped Hyaena (*Hyaena hyaena*) and panther (*Panthera leo*). Thus forest supports good wild life that can be improved by protecting/restoring food chains.

Although check dam is connected to the lake through pipes, but its water quality was found superior to lake during our detailed study, since wooden logs check free flow of water between them (Table 5, Fig. 8). The high evaporation losses dries check dam during summer.

Fig. 8. Check dam.

Almost two years of dry period (March 2006- June 2007) has led to establishment of *Prosopis juliflora* in the check dam from the neighboring areas which may hinder waterfowl's flights therein. Jaipur Development Authority must initiate its control at war footing otherwise this water body will be lost.

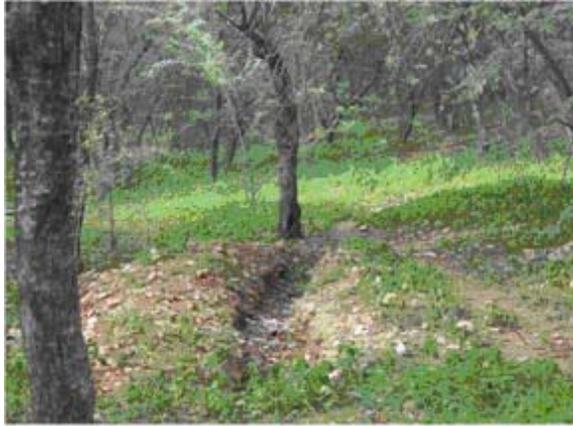
Fig. 9. Water harvesting structure (Trench) in the forest.

JDA funded (Rs.10 millions) to the State Forest Department for improving lake catchment falling in the Nahargarh hill area (Aravalli range); which is the only natural watershed surrounding lake almost from three sides. Various tasks completed so far are; dry stone wall fencing to minimize cattle menace from near by villages and loose rubble check dams, contour dykes and trenches for soil and water conservation (Fig. 9, 10). We found such structures very effective in conserving water during rainy season, since run off from the hills was very poor even after 4-5 good showers. As a result, hills turn green quickly. The forest department also made plantation that we did not find during our field surveys. All these measures help in conserving soil and moisture but cattle grazing continue uninterrupted in the rainy season.

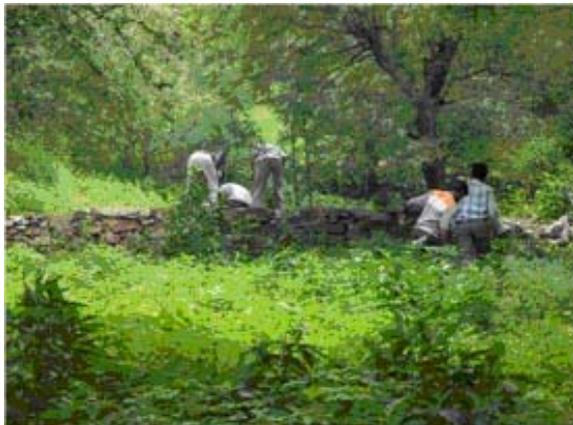
Fig. 10. Fencing wall (stone) for minimizing cattle grazing (also note ground forest vegetation during rainy season).

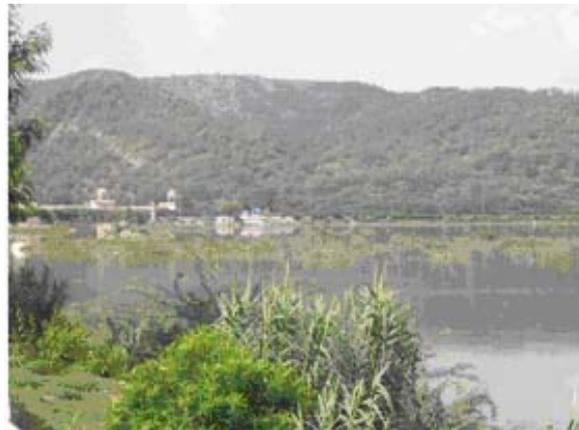
One serious mistake of the State Forest Department was sowing of *Prosopis chilensis* seeds (*P. juliflora*) in the year 1990s – an exotic tree species in the foot hill. This is now becoming a threat in the forest ecosystem. Today, it has formed a thick cover on the foot hill competing with native species. It is invading hills, especially in the disturbed habitats, through seeds dispersed by goat and wild herbivores feeding its pods due to high sugar content. The undigested seeds are dispersed in droppings on the hill where they germinate during rainy season. This species has even spread on the lake bank, its bed and Islands. We remove its saplings constantly along the bank and Islands. JDA also initiated its uprooting in May 2007, but only in a limited section. Those remaining are growing well despite being partially submerged in the water entering lake in the rainy season (July - September 2007; Fig. 11). It is thus evident that *Prosopis chilensis* is a very hardy species. Following our advice, its shoots are cut just

Fig. 11. *Prosopis juliflora* in the lake bed (Background).

below the water surface which may finally die due to oxygen non-availability under submerged condition.

We are of the view point that the Forest Department should have planted indigenous species commonly found on the foot hill of Aravallis. *Butea monosperma* is one such native species flourishing in the foot hills of Aravallis near Ramgarh, about 30km from Jaipur. Few *Butea* trees also grow on the hills surround lake (Fig 12). This species is very hardy, as it grows well in water scarce and rich habitats including in mild saline one. In view of this field observation, we planted *Butea* saplings along eastern bank of lake in July 2006, which was unsuccessful. Instead of saplings, this year (2007) we have sown its seeds along the lake bank in May 2007 and seedlings emerged after rains (July 2007) are growing well. Hopefully they will grow in the forthcoming years and this success story may encourage us to venture its plantation in areas presently dominated by *Prosopis chilensis* from where latter may be removed gradually.

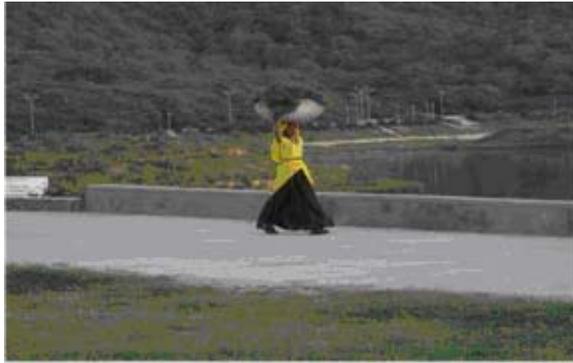
Anogeissus leaf litter in winter) depletes food availability to wild herbivores presently supporting 2-3 panthers in the forest, besides other predators (**Fig. 13**). Besides, 30-40 ladies of nearby localities often visits forest for collection of *Anogeissus* for fuel wood. Forest guard (one) is incapable to arrest illegal pasture and fuel wood collection due to muscle power of local communities engaged in these malpractices (**Fig. 14a, b**).

Fig. 13. A head load of grasses in the rainy season.

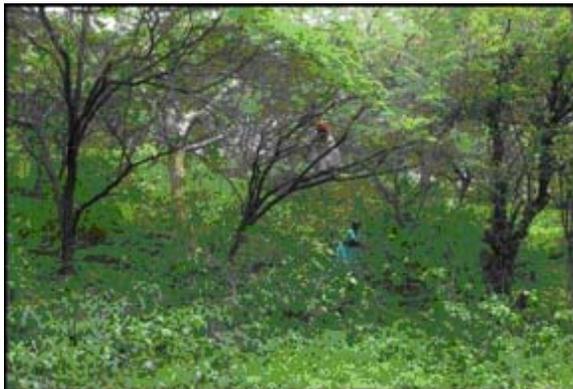
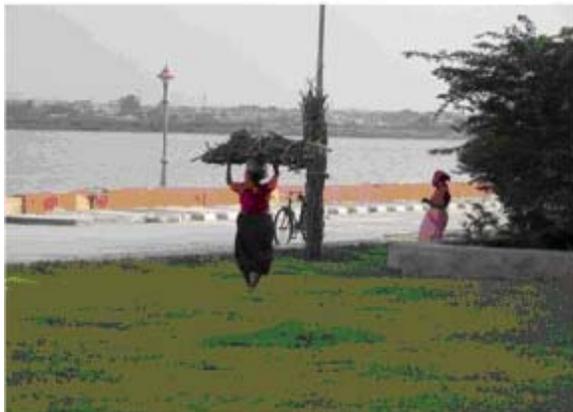
Fig. 14a. Tree lopping for fuel wood collection.

Fig. 14b. Head loads of fuel wood.

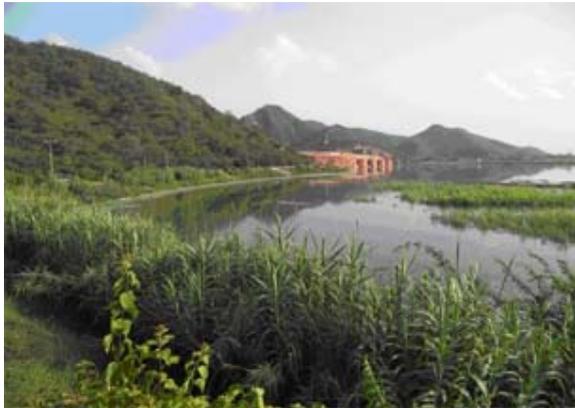
Fig. 15. *Arundo donax* stand along the bank.

The arrival of water in the lake during current rainy season (2007) inspired us to undertake massive plantation of *Arundo donax*, *Phragmites karka* and *Saccharum spontaneum* which is very successful. Other wetland species such as *Cyperus alopecuroides*, *Scirpus species*, *Typha angustata* etc. will be planted only after stabilization of water level in the lake since they prefer to grow only under partially submerged condition (20-30 cm water depth).

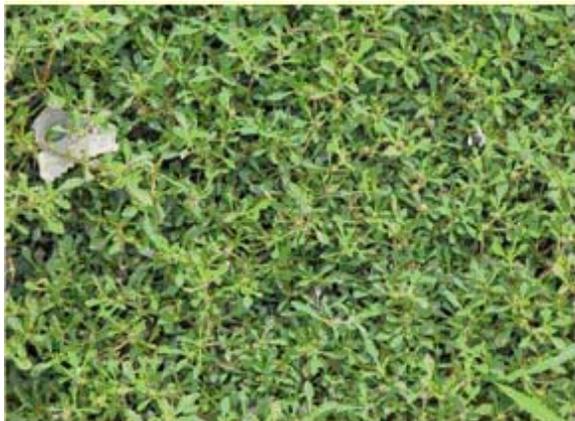
Fig.16. *Alternanthera sessilis* forming a thick carpet on the lake bed in the summer.

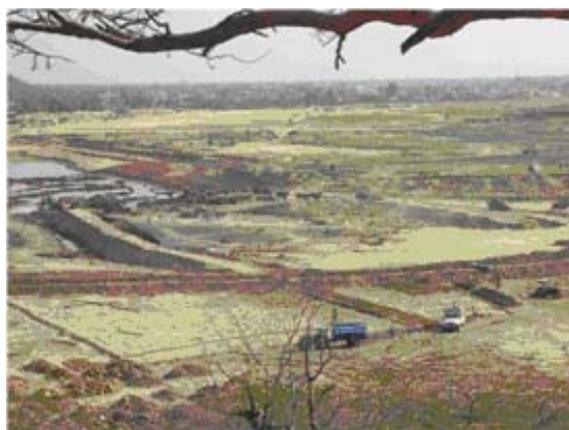
1. The construction of storm water management Plan was executed without EIA.
2. The storm water management structures are always made in the catchment area of a water body to facilitate its desilting and continuous solid waste removal, if any, accompanying with the storm water. However, in case of Mansagar lake, this structure begins at the discharge point to downstream, covering almost 1/5lake toward upstream. It has 4 interconnected large tanks;

most of them are damaged during the current monsoon. Since the first deepest tank has been made very near to reservoir foundation, it is likely that this tank may be silted in the event of torrential rains as in 1981, blocking the sluice gates with the sediment and plastic waste that may flood upstream areas. The release of water through sluice gates in July 2007 carried lot of sludge and plastics in the downstream which was objected by a priest residing in the temple constructed much before the Mansagar reservoir.

3. The earthen dams separate sedimentation tanks with the main lake disturbing lake hydrology. Earlier storm water entering on the western side of lake near Jalmahal palace used to travel almost throughout the lake basin before being discharged through sluice gates at southern end for irrigation in the downstream areas in the winter (Fig. 17). During its course, pollutant loads of the wastewater decreased markedly, as evident by physico-chemical characteristics of water collected from southern end. In the event of excess rainfall, as noted in October 2005, the surplus water was even released during the rainy season, which diluted pollutants maximum and water qualities of the lake was parallel to any unpolluted one in the region. This arrangement helped in washing out of salts and nutrients from the lake (Table 2). This scenario has now changed. Now water passing through sedimentation tanks will enter in to the lake. After attaining the desired level, only surplus water will be discharged directly through the sluice gates without passing lake basin; thereby there shall be no more dilution of pollutants in the lake. Under the present lake management plan, a constant water level will be maintained in the lake round the year by compensating evaporative losses using tertiary treated sewage. The evaporative losses will concentrate salts during summer and in the absence of flow of storm water through the lake basin, they will only be diluted to some extent but not washed out in the ensuing rainy season. As a result, salt contents will gradually built up with time turning freshwater body in to a brackish one that will alter its flora and fauna including of surrounding areas. All heritage monuments such as Jalmahal, Kanak Vrindaban and other nearby temples etc. will also suffer from increased salinity of lake. Further, groundwater qualities of the vicinal areas will also deteriorate leading to serious water crisis. Our assumption derives support from the water quality data collected for two years (Table 1).

Further, construction of sedimentation tanks has failed to check influx of solid wastes in the lake while maximum reduction of silt load as claimed by the experts of Jalmahal Resort Pvt. Ltd. is meager (20%) that too will stay in the sedimentation tanks

Fig. 17. Sedimentation tanks in the lake bed.

for ever. Surprisingly, after failure to deliver expected services of sedimentation structure, the Jalmahal Resort Pvt. Ltd. allowed entry of storm water runoff from the earlier water course thereby raising doubts in mind about purpose of such structures. Further, these structures are also unsafe for wild life due to sudden increase in water depth at the bank. One Sambhar calf rescued by the Forest Department from the sedimentation tank (August 2007) died after hospitalization. Should be call storm water management plan- an effort for better future of the lake or its grave?

sedimentation tanks. In our opinion, the size of land for public-private partnership should be limited to 60 hectares. The remaining 40 hectares should have been diverted to storm water management and additional land for tertiary treatment system for treated sewage. Our hypothesis derives strength from Limnological data collected by us from March 2005-April 2007. If State Government is serious about the future of this lake, she can rectify her mistakes by ordering dismantling of construction in the lake bed, reducing size of leased land for sedimentation tanks and tertiary treatment system, since Jalmahal Resort Pvt. Ltd. has yet not begun construction on the leased land.
